CORO ANNOUNCES RESULTS FROM MARIMACA PROJECT DUE DILIGENCE

Due Diligence Sampling and Mapping Results

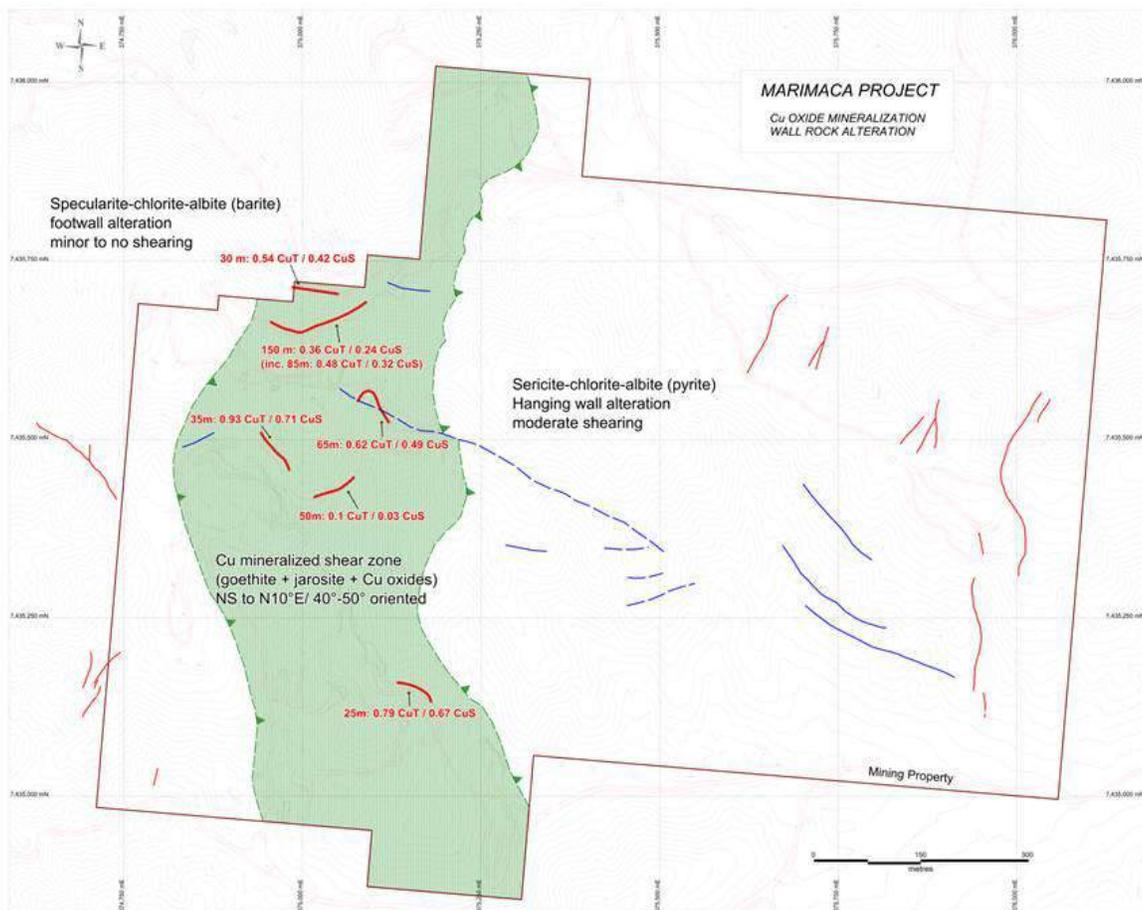
Figure 2; Marimaca Geology, Mineralization and Sampling

The mineralization, occurring as malachite and chrysocolla, appears to be present within the shear as several higher grade, elongated, lenticular zones parallel to strike possibly located in zones of dilation, surrounded by lower grade halos, and separated by internal waste blocks. A series of NS oriented, mineralized, sub vertical structures transect the shear zone. The sampling program was designed to be as representative as possible of the entire shear zone, avoiding focusing on obviously high grade mineralization in existing workings that could have otherwise skewed the overall results. Figure 2 shows the location of the chip channel samples and the shear zone, while Figure 3 is an annotated photograph showing the dip of the mineralized zone.

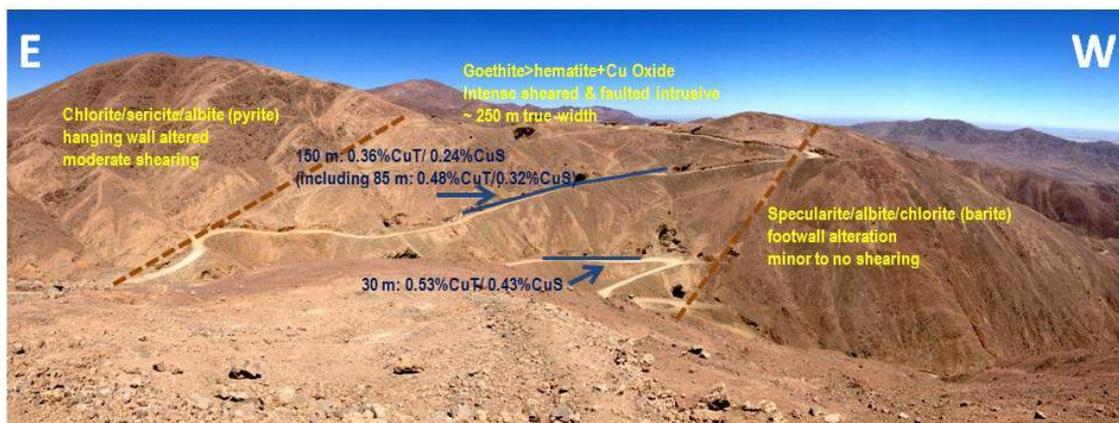
Figure 3 Annotated Photo Looking to S, Showing Marimaca Alteration and Mineralization
